ASSESSMENT OF DAM SAFETY OF COAL COMBUSTION SURFACE IMPOUNDMENTS

**Crisp County Power
Commission
Plant Crisp
Warwick, Georgia**

Prepared for
*U.S. Environmental
Protection Agency
Washington, D.C.*

November 2012

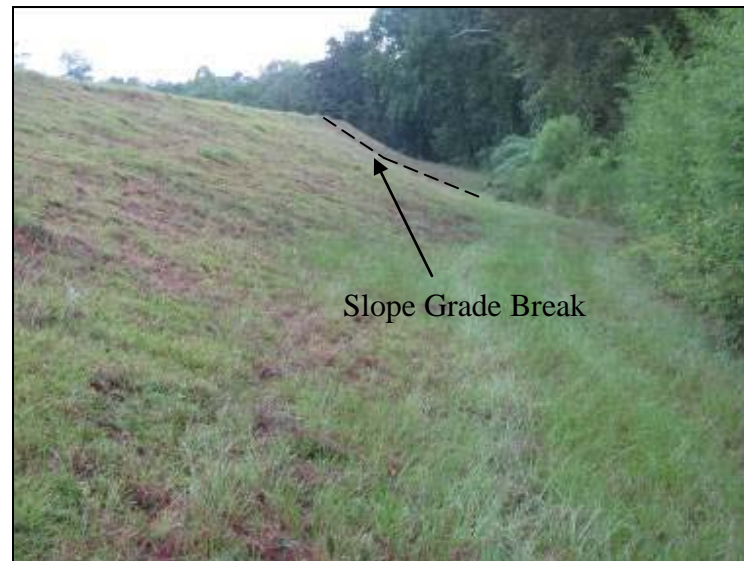
Photo 6: Ash Pond – North embankment exterior slope, change in slope grade from approximately 2.8 H:1V to 2H:1V, looking west.

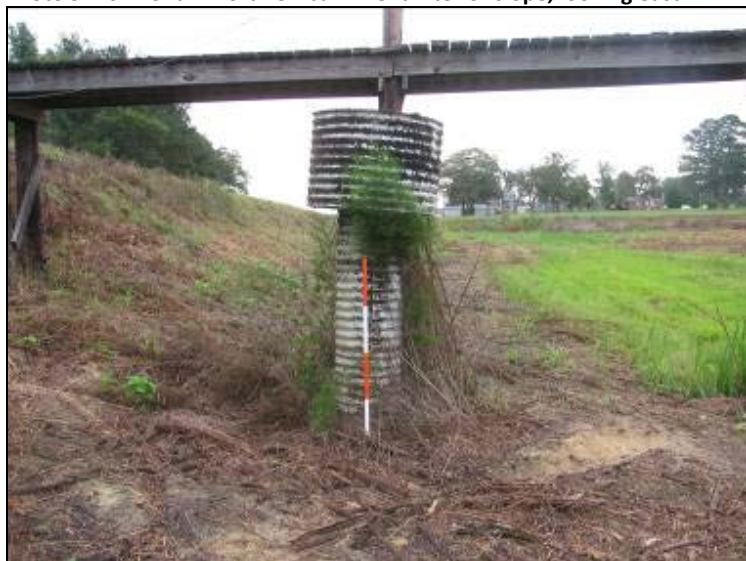
The outlet structure consists of an 18-inch diameter corrugated metal riser pipe (CMP), with an approximate 2-foot high 36-inch CMP trash-rack at the neck of the outlet pipe. This outlet is located near the central portion of the north embankment (Photographs 11, 12 and 64). Based on the drawings provided by the Crisp County Power Commission (Appendix A), we understand that this riser pipe connects into a 12-inch CMP and discharges near the toe of slope of the north embankment. CDM Smith was not able to locate the exit pipe due to the high vegetation at the apparent outfall/discharge location.

Photo 11: Ash Pond – North embankment interior slope, 18-inch outlet riser pipe, looking east.

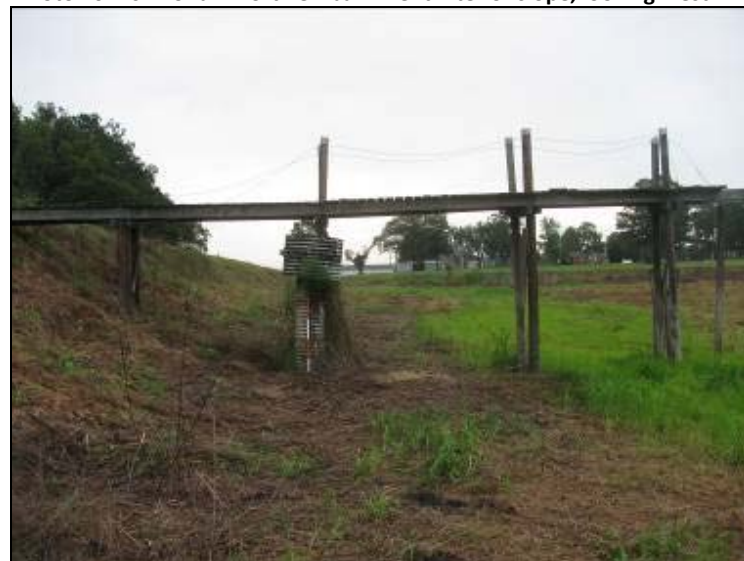
Photo 12: Ash Pond – North embankment interior slope, boardwalk and 18-inch outlet riser pipe looking east.

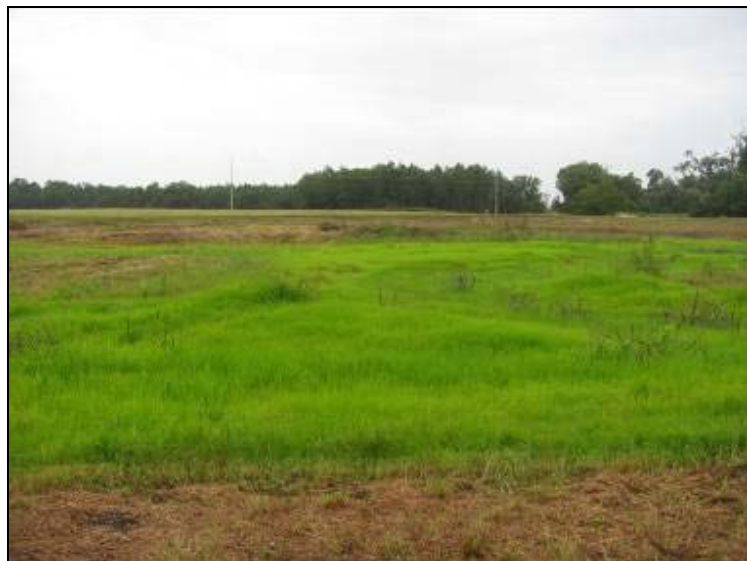
Photo 13: Ash Pond – General view of pond bottom surface, looking south.

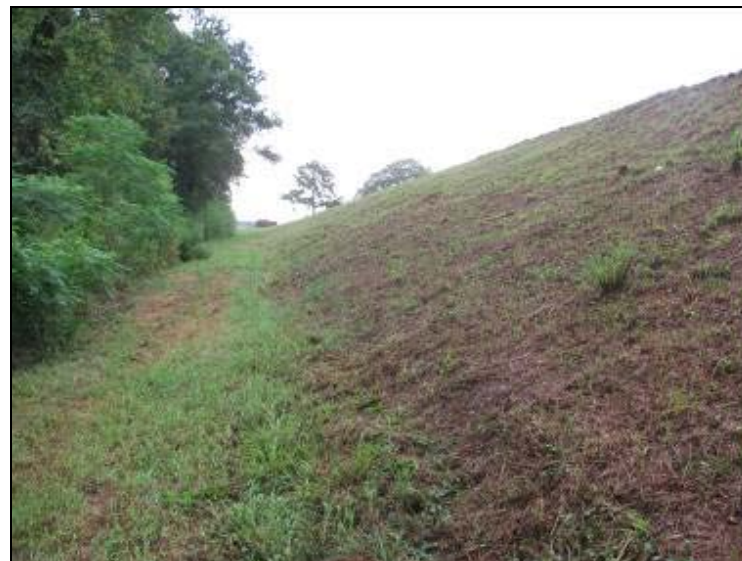
Photo 14: Ash Pond – North embankment exterior slope, looking east.

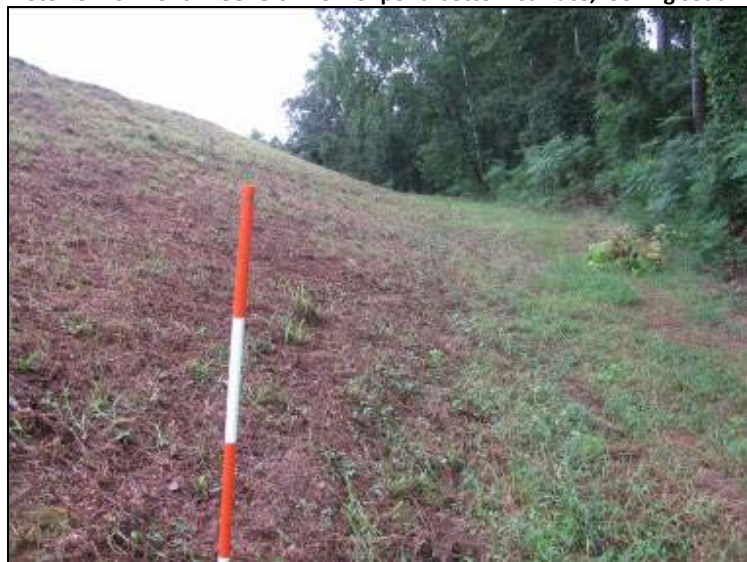
Photo 15: Ash Pond – North embankment exterior slope, looking west.

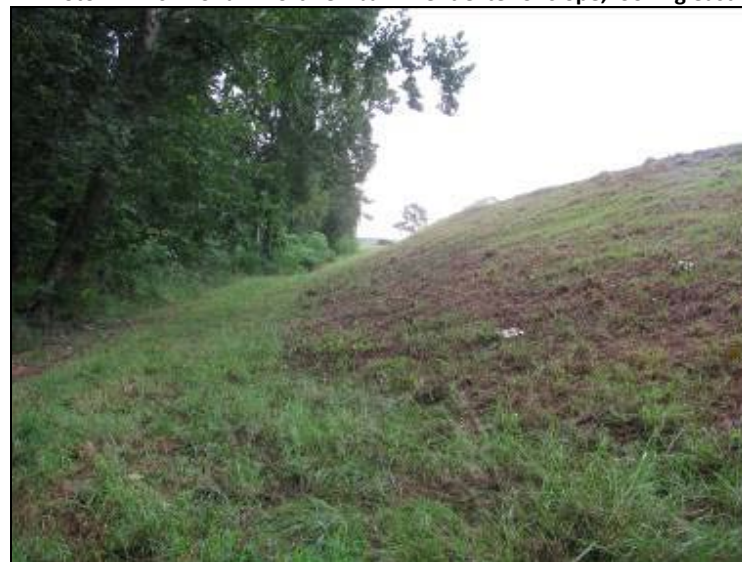
Photo 16: Ash Pond – North embankment exterior slope near northwest corner, looking east.

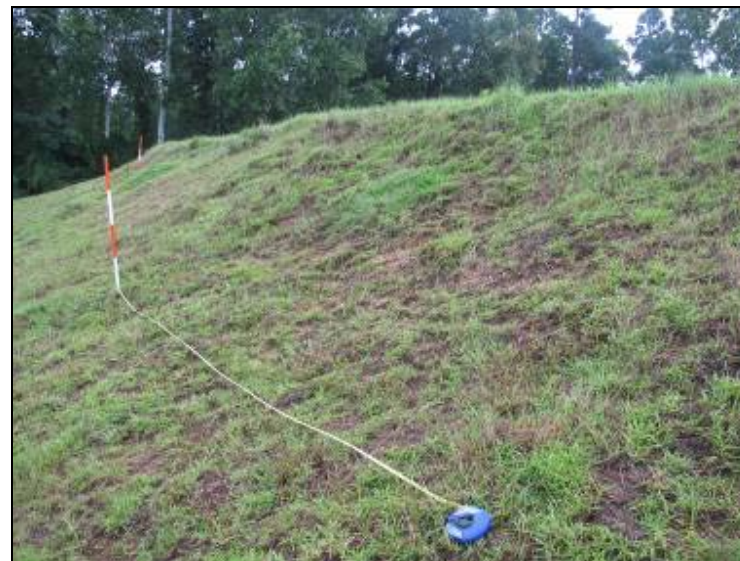
Photo 22: Ash Pond – West embankment exterior slope, apparent 16-foot long semi-circular sloughing, looking north.

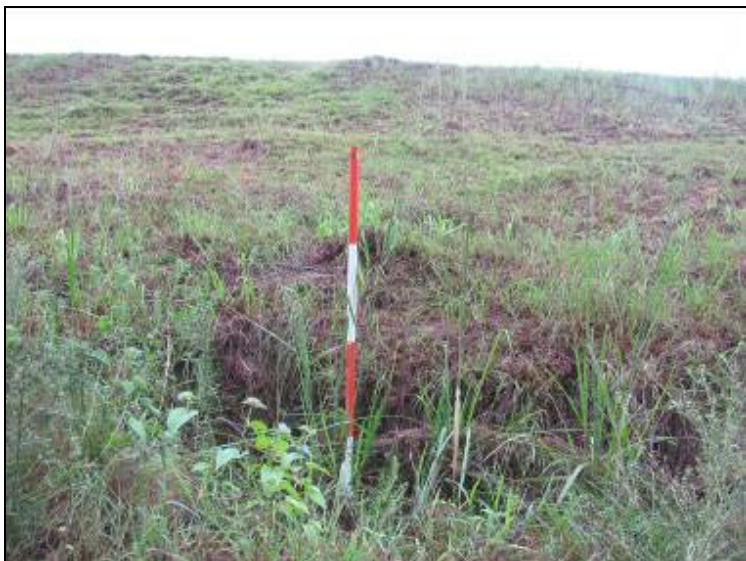
A runoff swale was cut into the toe of the slope of the west embankment (Photographs 29 to 31). It was reported by the Crisp County Power Commission representatives that the toe of slope of the west embankment extends beyond the plant property line.

Photo 29: Ash Pond – West embankment exterior slope, swale cut at toe of slope, looking east.

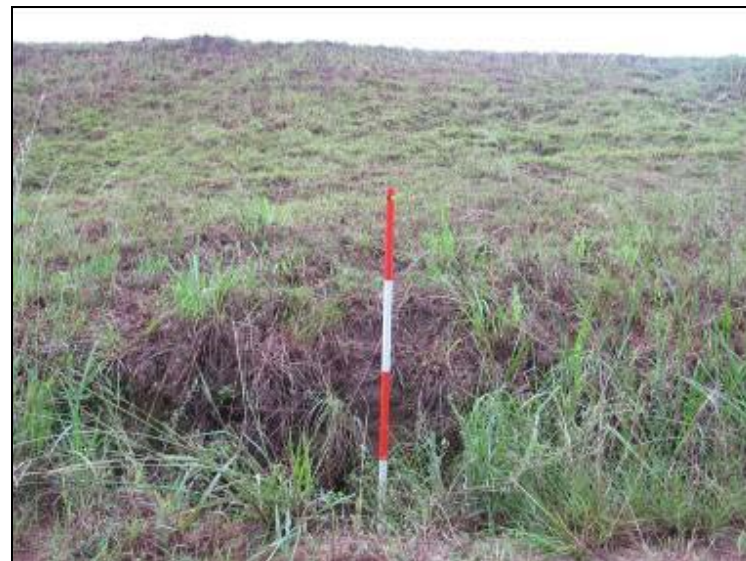
Photo 30: Ash Pond – West embankment exterior slope, swale cut at toe of slope, looking east.

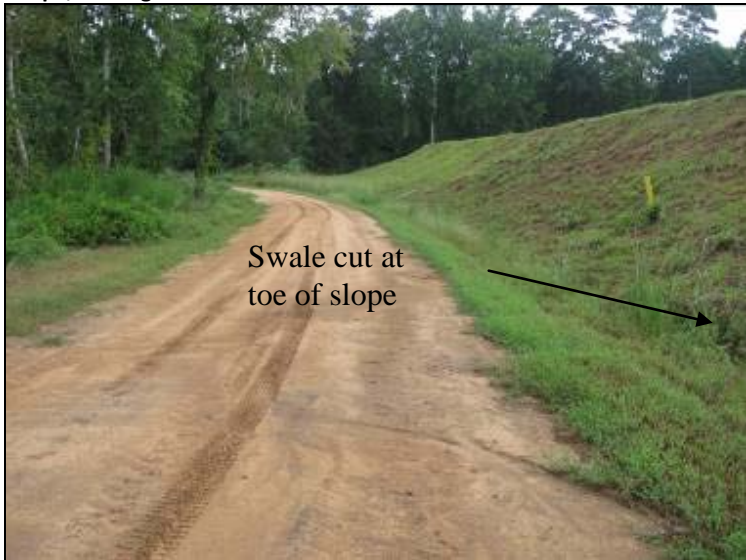
Photo 31: Ash Pond – West embankment exterior slope, toe of slope and road looking north.

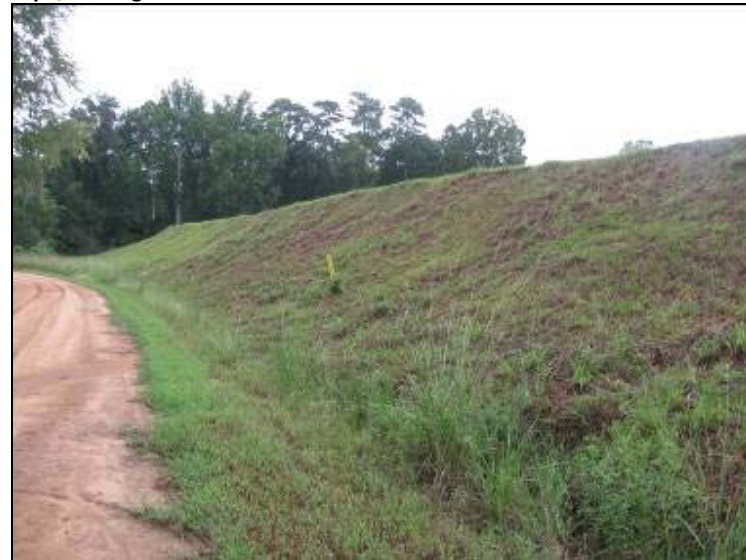
Photo 32: Ash Pond – West embankment exterior slope near southwest corner, looking north.

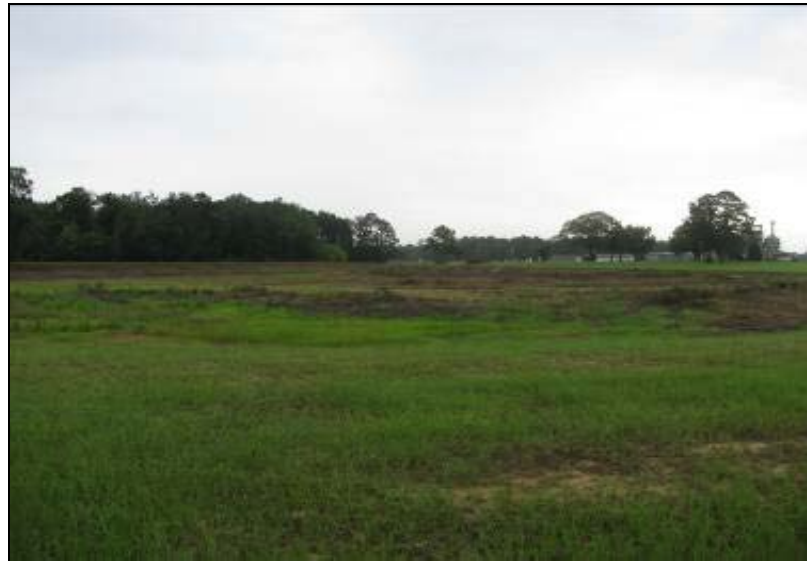
Photo 36: Ash Pond – General view of pond surface area looking northeast.

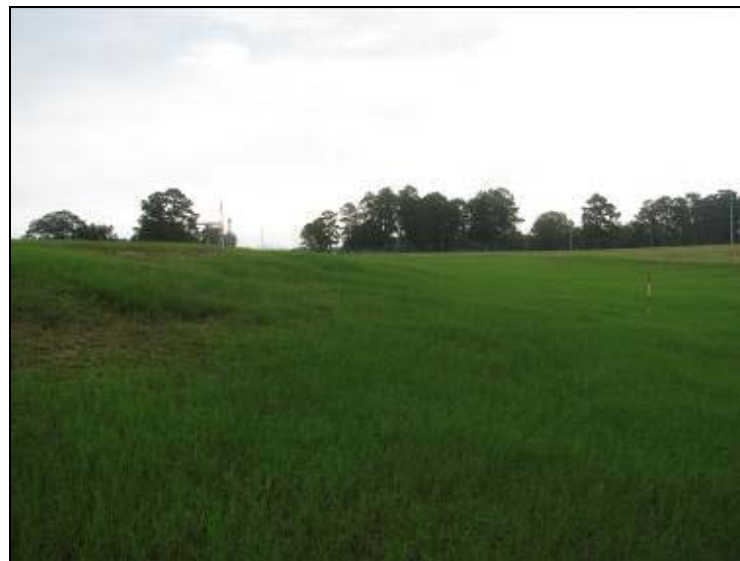
Photo 38: Ash Pond – South embankment exterior slope, looking east.

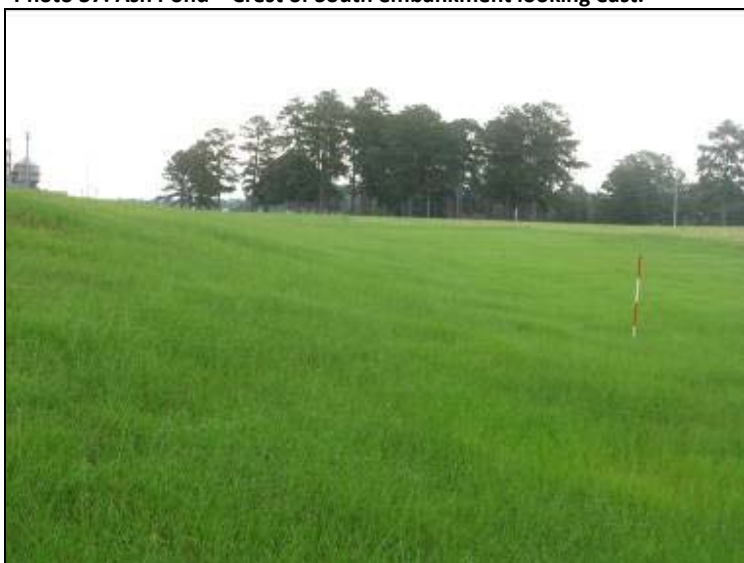
Photo 39: Ash Pond – South embankment exterior slope, looking east.

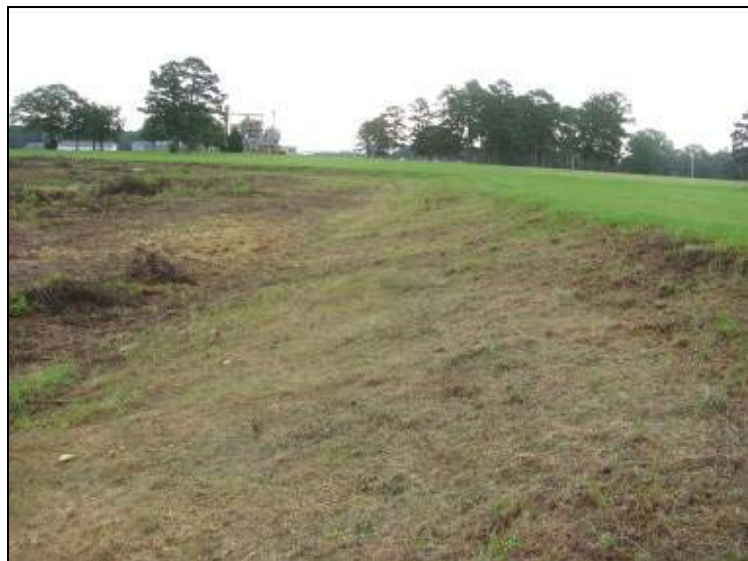
Photo 42: Ash Pond – South embankment interior slope, looking east.

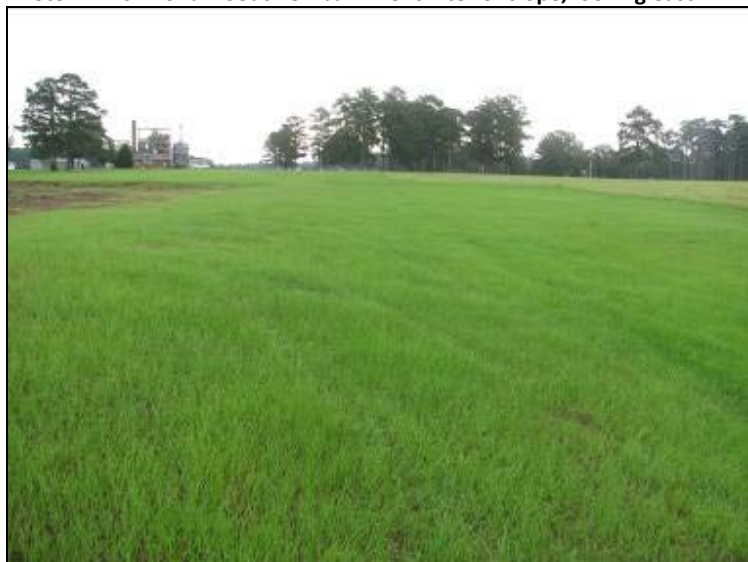
Photo 44: Ash Pond – South embankment exterior slope, looking east.

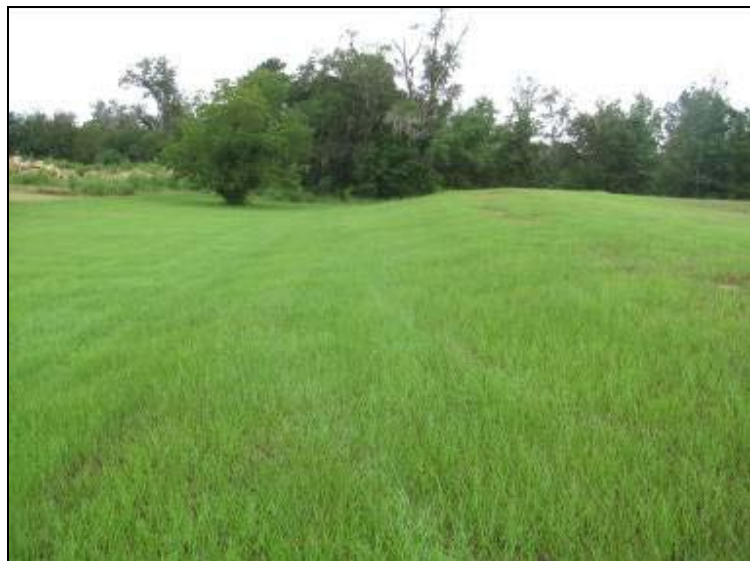
Photo 45: Ash Pond – South embankment exterior slope, looking west.

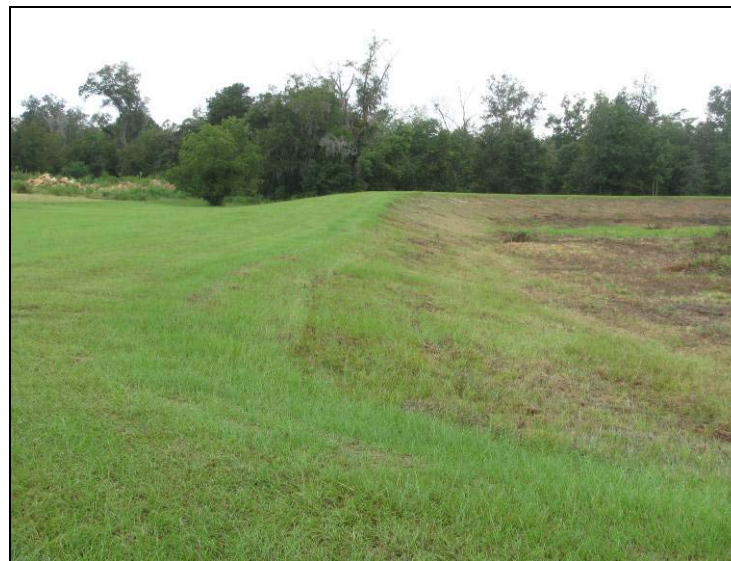
Photo 46: Ash Pond –Crest of South embankment near southeast corner looking west.

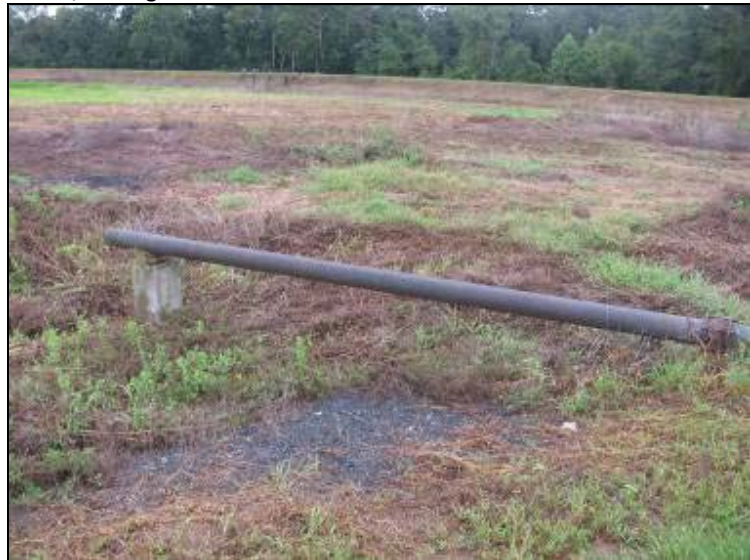
The Ash Pond has two inlet pipes located on the southeast embankment (Photographs 4, 51, and 55); one, 8-inch polyvinyl chloride (PVC) pipe and one, 7-inch inside diameter ductile iron pipe (DIP). During the visual assessment water from the plant was discharging through the 8-inch PVC pipe (Photograph 63).

Photo 51: Ash Pond – Southeast embankment interior slope, 7-inch I.D. Ductile iron pipe looking northwest.

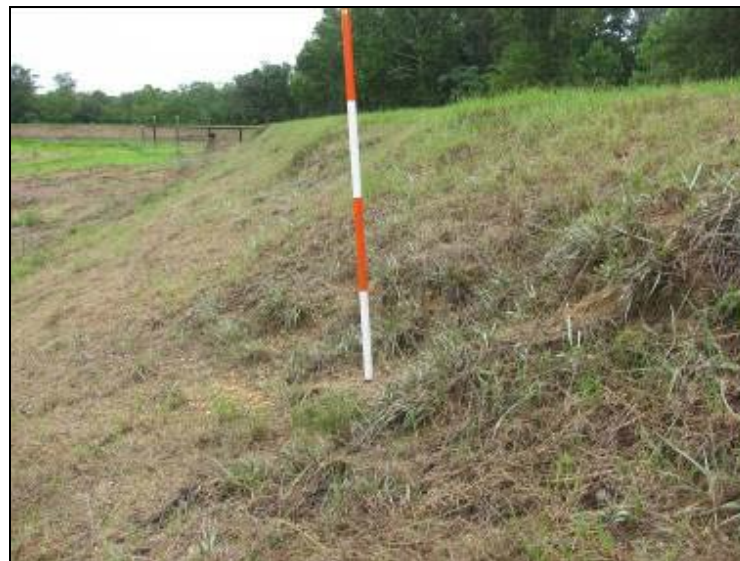
Photo 61: Ash Pond – North embankment interior slope surficial erosion, looking north.

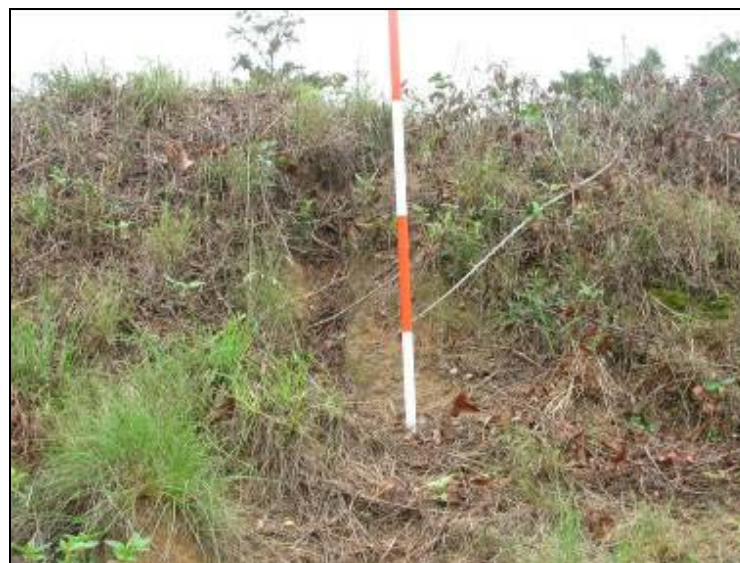
Photo 65: Ash Pond – North embankment interior slope, looking north.
Note: boulder (12"-24") and steepness of slope (2H:1V).

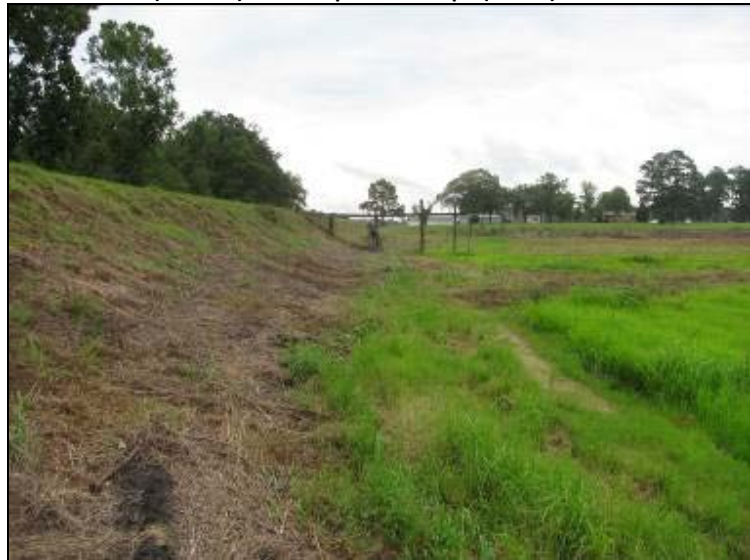
Photo 66: Ash Pond – North Embankment interior slope, erosion rills near outlet structure looking north.

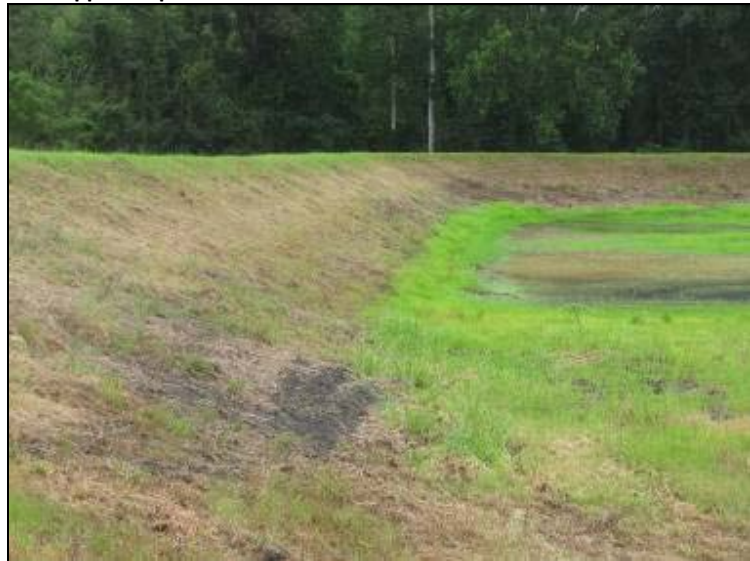
Photo 70: Ash Pond – West embankment interior slope surficial erosion/scarp, looking west.
